Draft Report

Circleville Norfolk Southern Railroad Crossing Study

Circleville, Ohio

January 23, 2015

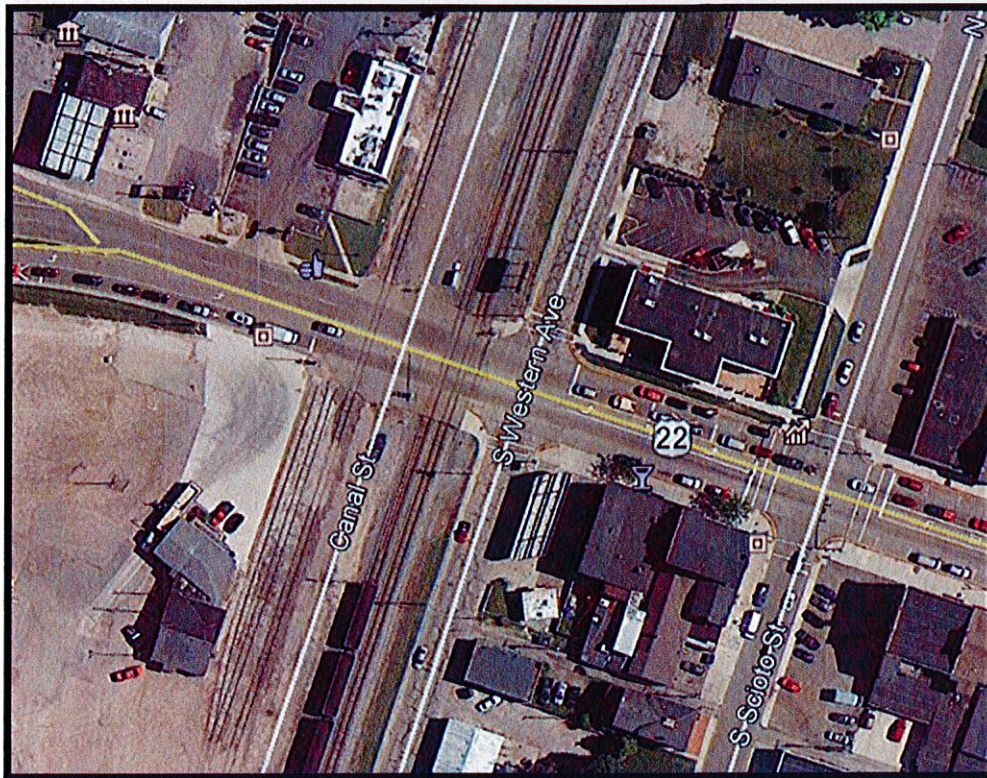
Figure 3-3: S. Western Avenue at W. Main Street (US 22) Aerial

As can be seen in **Figure 3-3**, the laneage of the westbound, northbound and southbound approaches is one lane. The eastbound approach is striped for one through lane and one continuous left-turn lane west of the railroad crossing. There is no approach striping across the railroad tracks or within 150 feet of the centerline of S. Western Avenue. Review of traffic operations for this intersection showed that the left-turn lane is used as a through lane on the eastbound approach of W. Main Street at S. Western Avenue 33 to 40 percent of the time during the morning and afternoon peak periods, respectively. There are two receiving lanes for both the eastbound and westbound departure legs. There is on-street parking marked on both sides of the east leg and on-street parking is used on the departure side of the south leg.

The intersection of S. Western Avenue and W. Main Street (US Highway 22) is a four-leg intersection located just east of the W. Main Street Main Line crossing (#481424H.) **Figure 3-3** shows an aerial view of this intersection. The centerline of S. Western Avenue is located 45 feet east of the nearest track edge of the W. Main Street crossing. The intersection control is minor-street stop control for the S. Western Avenue approaches and free-flowing on W. Main Street unless there is a train approaching the crossing and the warning devices are activated. There is a stop bar on the westbound approach on W. Main Street at the intersection with S. Western Avenue indicating where vehicular traffic should stop in the presence of a train. There is a signalized intersection in close proximity to the study intersection at W. Main Street and S. Scioto Street. The stop bar for the eastbound approach at this adjacent signalized intersection is 170 feet east of the centerline of S. Western Avenue. The intersection of W. Main Street with Canal Street is located between the railroad tracks is approximately 90 feet west, centerline-to-centerline, of S. Western Avenue.

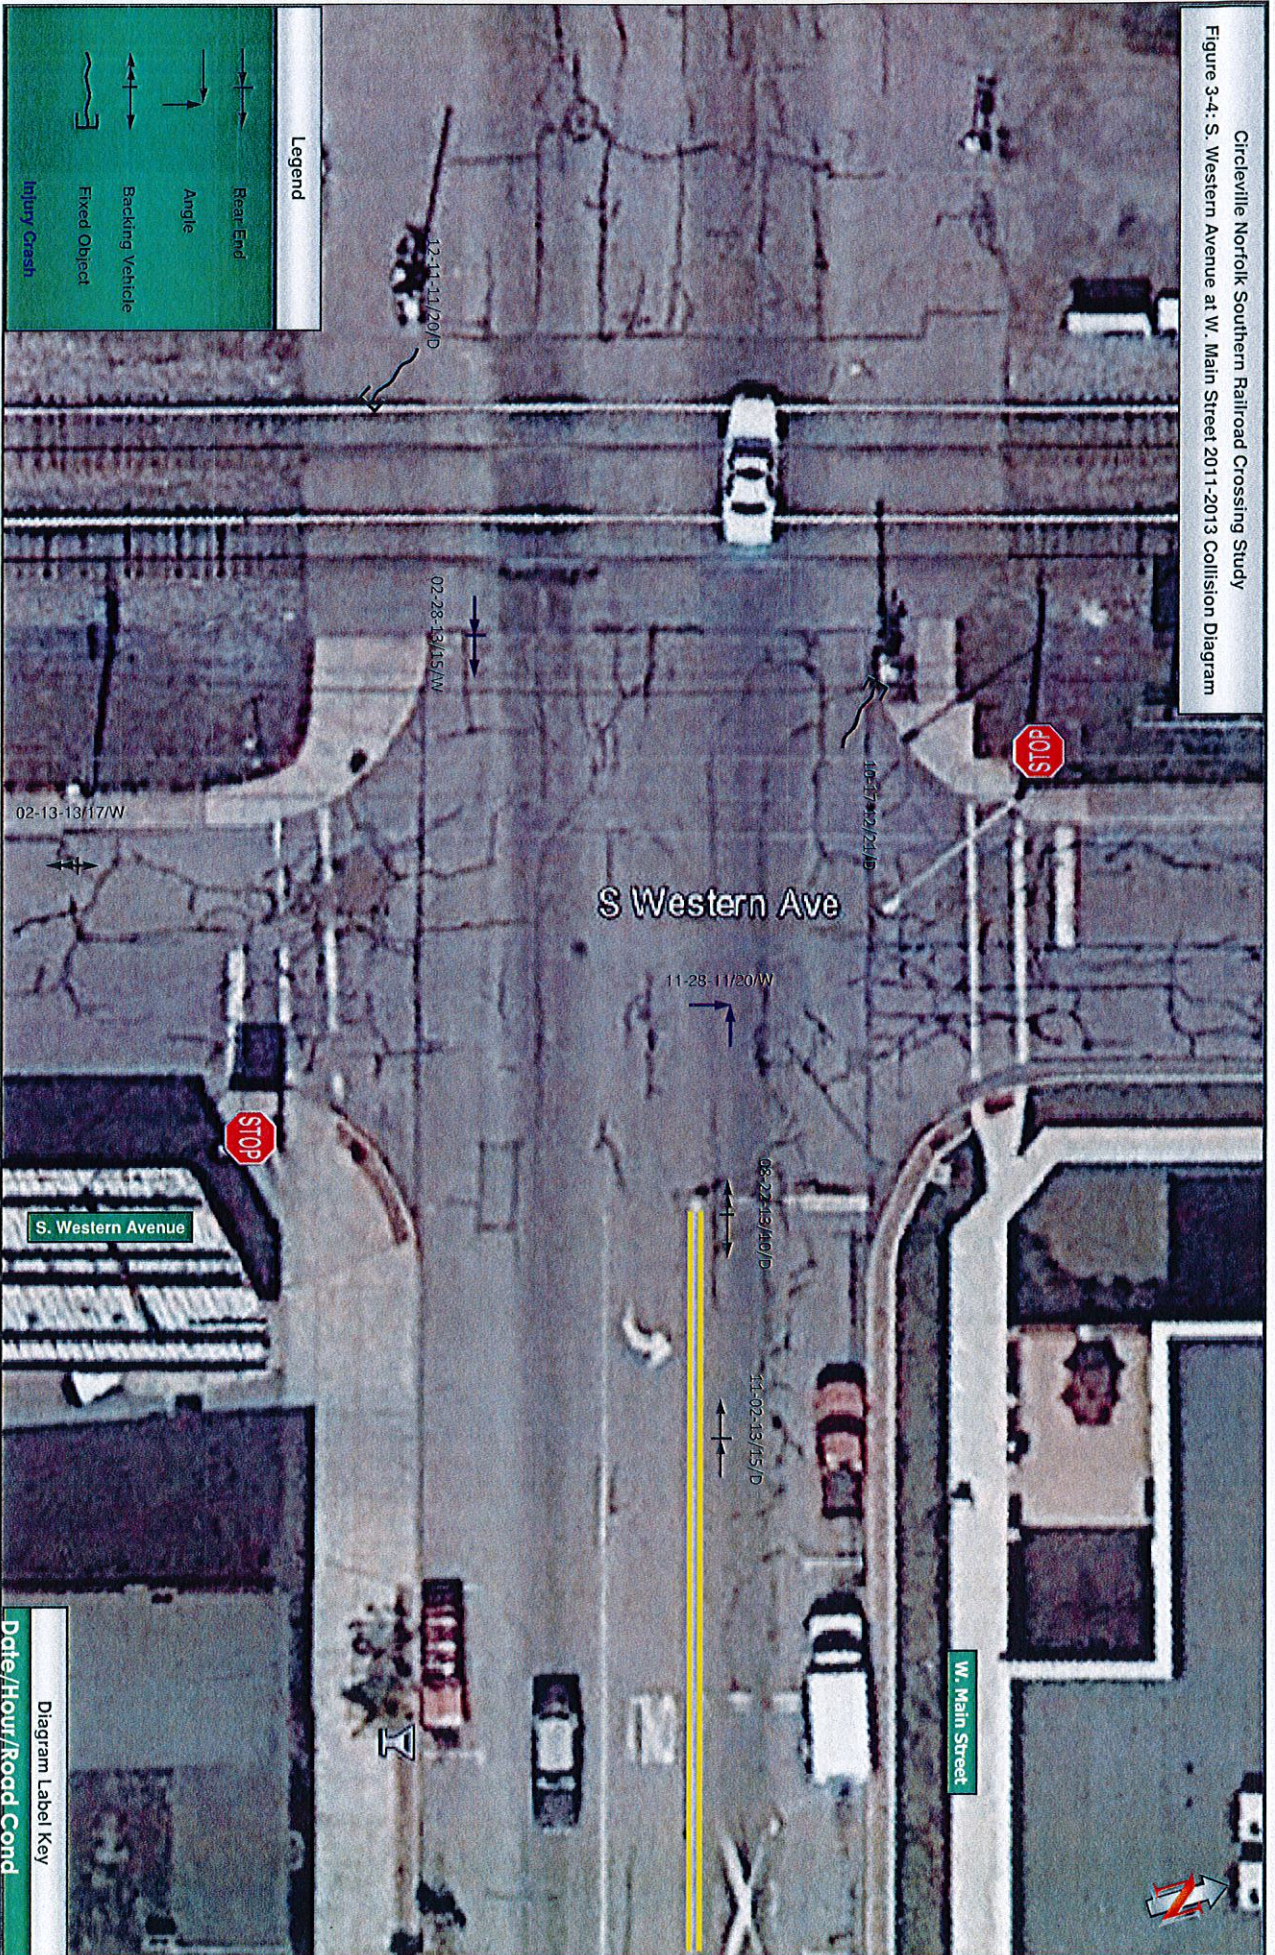
Circleville Norfolk Southern Railroad Crossing Study
 Figure 3-4: S. Western Avenue at W. Main Street 2011-2013 Collision Diagram

Backing, fixed object, and rear end crash types each had two crashes in the last three years at this intersection. Both backing collisions and one of the fixed object collisions, involved backing out of or into the on-street parking on W. Main Street and S. Western Avenue, so location and/or signing of parking areas could warrant further evaluation. Vehicle queues extending from the signalized intersection with Scioto Street through the intersection with S. Western Avenue on W. Main Street were observed during the afternoon peak hour. Vehicles will also queue in the westbound direction when a train is present on the railroad tracks. Both of these queuing instances will contribute to the occurrence of backing and rear end collisions. Changes to the signal timing during the afternoon peak period could be considered to reduce the queuing in the eastbound direction.

There were seven vehicle crashes in the years 2011, 2012, and 2013 that occurred at the intersection of S. Western Avenue and W. Main Street or on a leg immediately adjacent to the intersection that did not occur on the railroad crossing with the presence of a train. **Figure 3-4** is a collision diagram showing the crash locations and details on an aerial image of the intersection. **Table 4-3** identifies important details of the seven crashes. A review of the crash reports for these crashes was conducted and the reports are included in **Appendix E**.

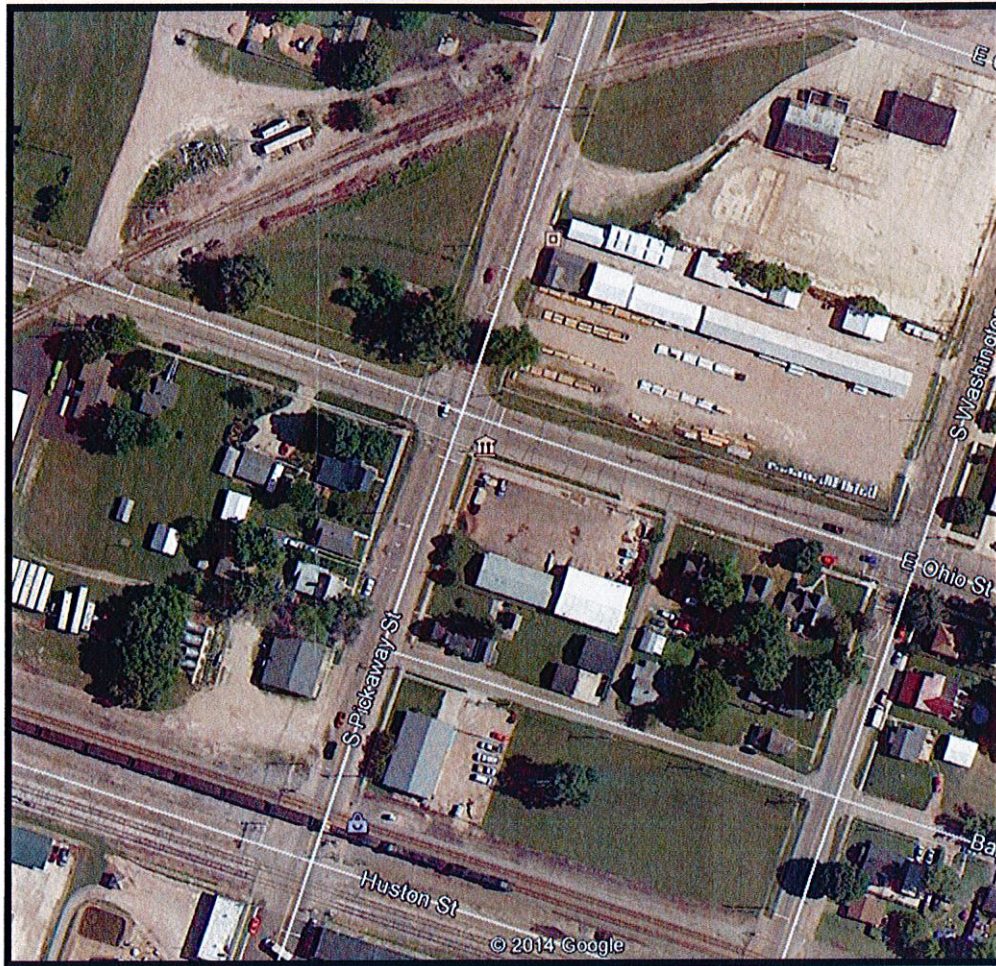
Figure 3-5: S. Pickaway Street at E. Ohio Street Aerial

The intersection of S. Pickaway Street and E. Ohio Street is a four-leg intersection that has one approach lane and one departure lane per leg and operates under all-way stop control. **Figure 3-5** shows an aerial view of this intersection. There are three railroad crossings whose nearest track edge is within 435 feet of this intersection. The Other Lines crossing on E. Ohio Street (#514840F) is located approximately 400 feet west of the center of the intersection. The Other Lines crossing on S. Pickaway Street (#514839L) is located about 360 feet north of the intersection, while the Main Line crossing on S. Pickaway Street (#481415J) is approximately 435 feet south of the intersection.

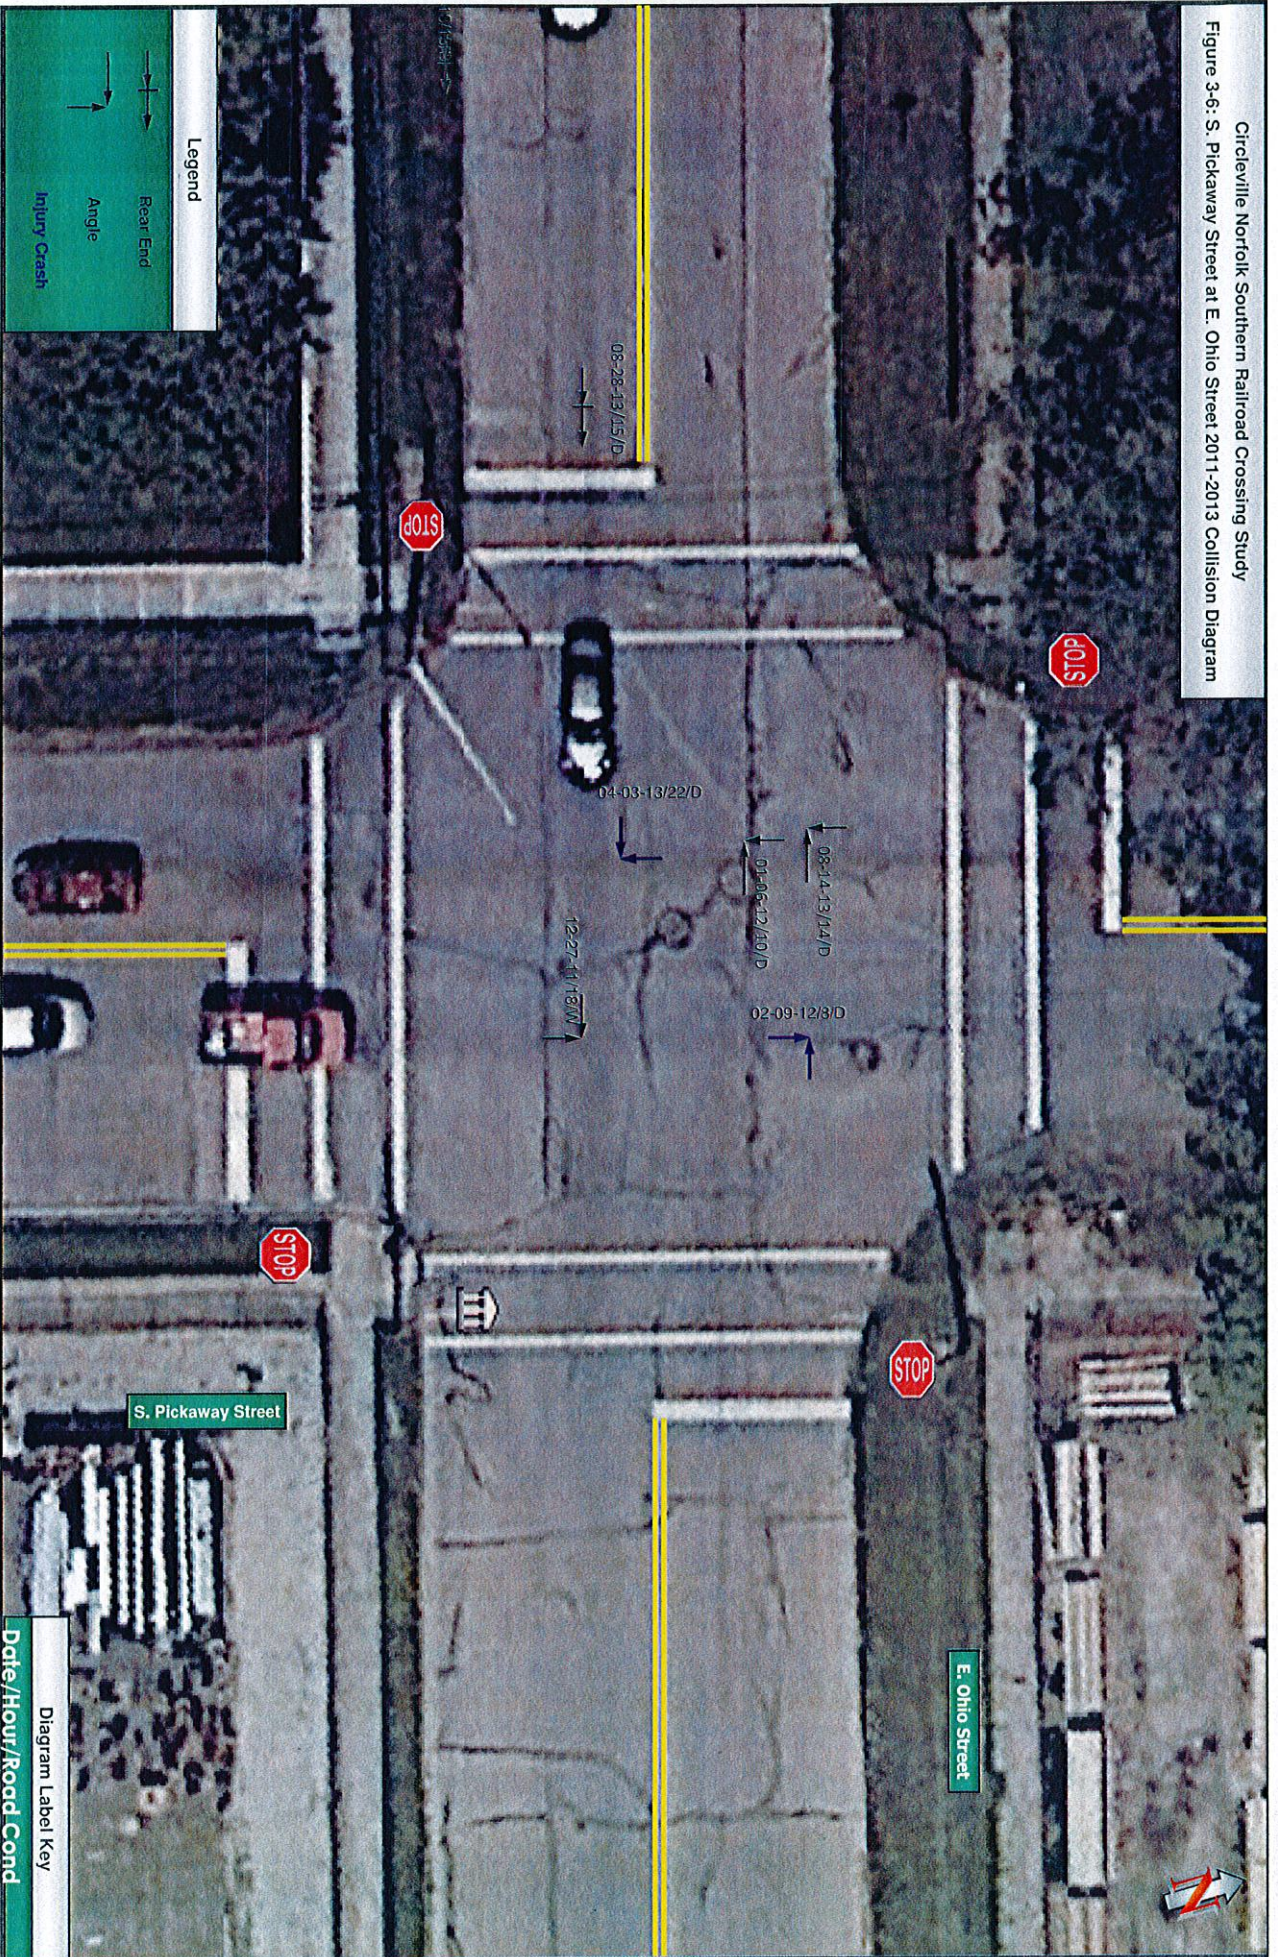
Creleville Norfolk Southern Railroad Crossing Study
 Figure 3-6: S. Pickaway Street at E. Ohio Street 2011-2013 Collision Diagram

Five of the six collisions, during the years 2011, 2012, and 2013, at the intersection of S. Pickaway Street and E. Ohio Street were angle collisions. The contributing circumstances for these collisions were drivers who did not follow the traffic control and stop at the intersection, or stopped and then proceeded into the intersection without ensuring that there were no other vehicles in the intersection. An analysis to determine the appropriateness of all-way stop control at this intersection is recommended. Additionally, an evaluation of the signage at this intersection and an upgrade to current sign standards, if necessary, and restriping of pavement markings is recommended.

There were six vehicle crashes in the three-year study period that occurred at the intersection of S. Pickaway Street and E. Ohio Street or on an approach to the intersection. **Figure 3-6** is a collision diagram showing the crash locations and details on an aerial image of the intersection. **Table 3-4** identifies important details of the six crashes. A review of the crash reports for these crashes was conducted and the reports are included in **Appendix E**.

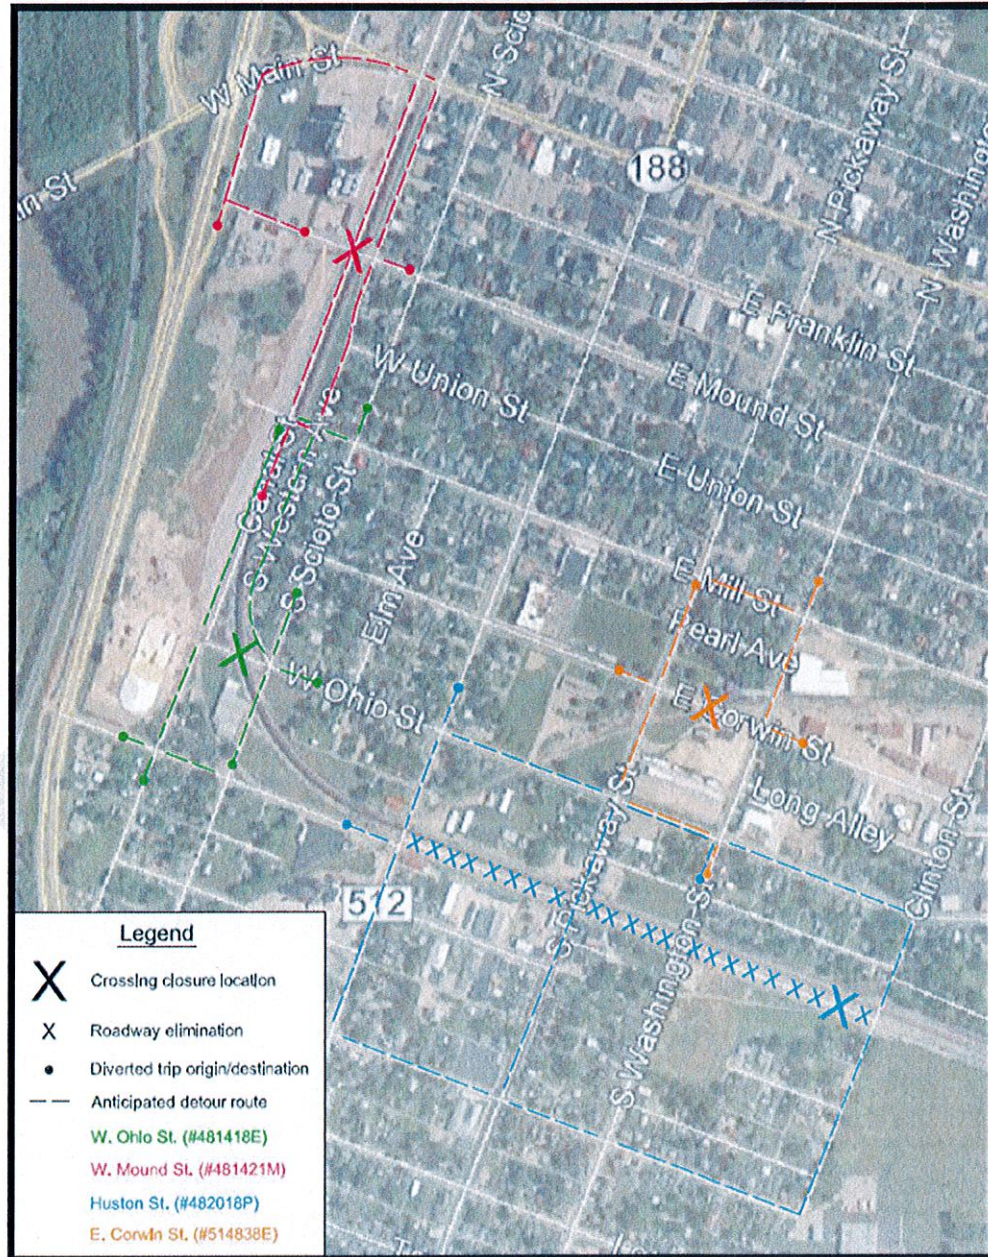
Figure 5-1: Closure Alternative 1 Detour Routes

conditions with the applicable railroad crossings closed. Existing vehicle traffic using the roadways and crossings affected by the closures were manually diverted and assigned to nearby roadways and crossings, as appropriate, for the morning and afternoon peak hours individually. **Figures 5-1** and **5-2** show the locations of closed railroad crossings for each of the two closure alternatives along with the detour vehicle paths that were determined based on the existing turning movement count data on the adjacent roadways and used for the assignment of diverted traffic volumes.
